Castel Belasi's special underpinning and reinforcement project

ABSTRACT: This document provides a description of the structural recovery of the ancient complex known as "Castel Belasi". The worsening of the cement binder of the perimetric walls, along with the creep of the slope on which the castle stands, has brought about visible instability with angular distortion and such an extensive crack pattern that the structural integrity of many walls is at risk. From the first on-site survey (cognition stage) the main reasons for this decay were analysed (analysis stage) and a series of interventions were drawn up (project stage) in order to stop the creep of the slope and to reinforce the wall base (under-foundations and underpinnings, even with micro-piles).

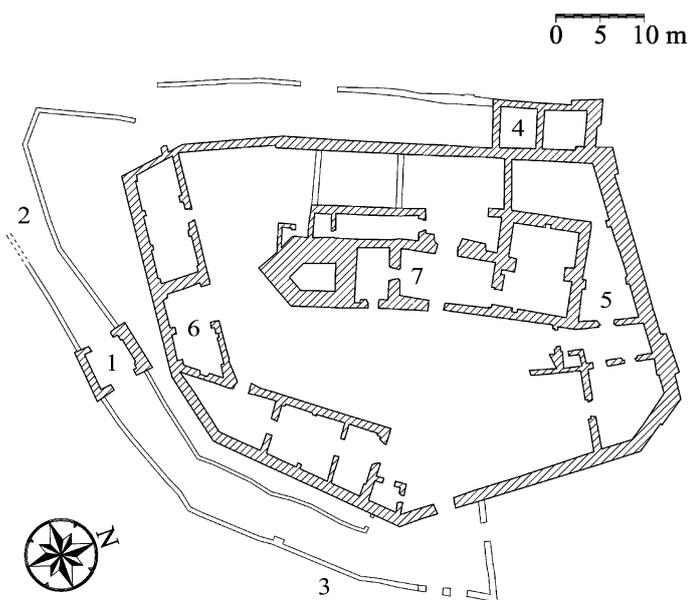
Figure 3. Castle's layout. (1) Guardhouse; (2) Supporting wall by the entrance (southern side); (3) Supporting wall (eastern side); (4) Custodian's lodge; (5) The castle – northern block; (6) The castle – southern block; (7) The castle – central block.

It provides one of the best examples of a castle with a continuous evolution. From the original fortified complex, that probably consisted of a simple enclosure with a central keep, to the residential castle, from the era of its foundation until the 20th century. Given the building materials used that cannot be found locally (granite) and the remarkably high walls, it is clear that this castle has always been a fortified site of a certain importance (Primerano 1989). The first interventions were carried out at the turn of the 15th century and it started its gradual evolution into a noble residence. The entrance doors were built and the noble residence in the centre of the enclosure was created from the union of three different buildings: the pentagonal tower, a regular form construction to the north of the tower and a central body that connected these two structures (Fig. 3). The chapel was also

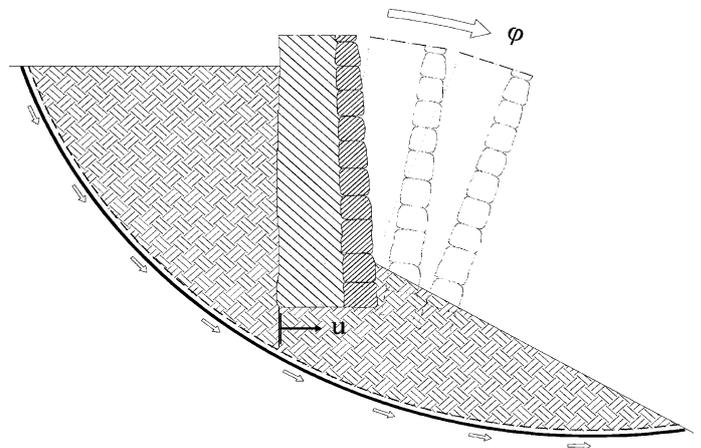
Figure 4. Supporting wall by the entrance. The wall clearly appears to be rotated towards the valley.

2) Supporting wall by the entrance (southern side). The wall clearly appears to be rotated towards the valley. In particular, in the most deformed part the height is 4.30 m with a value of differential horizontal displacement of 0.71 m, a remarkable value if compared to the height. Moreover, the wall has no foundation and the basement of the wall is approx. 0.70 m under the ground level. Longitudinally the wall shows vertical cracks from top to base, even quite wide, and some stone fragments have come off. The wall looks washed out

since there is no fixing mortar in places (Fig. 4). The instability may have resulted from: the active thrust of the soil behind the wall, the creep of the slope and the under-sizing of the wall foundations and of the wall itself.

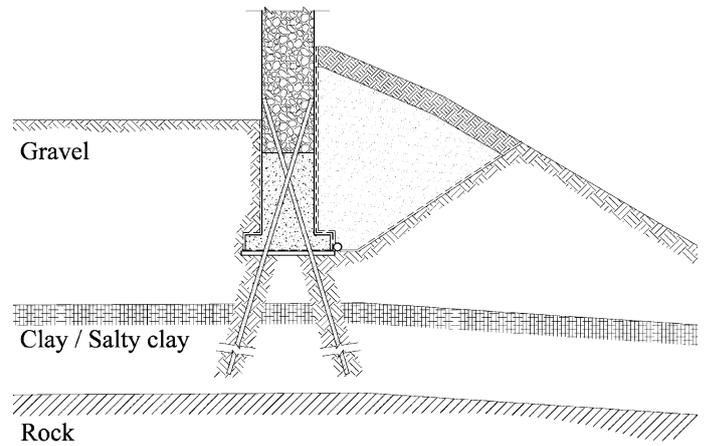
Figure 5. Underpinning with sub-vertical piles.

1) Walls: underpinning works. These regard the northern block of Castel Belasi. It consists of underpinning and connection to the existing walls made of reinforced concrete and sub-vertical piles with small diameter (micro-piles $\varnothing = 101$ mm) positioned at an axes distance $d = 1.00$ m from one another, with a stagger of 0.50 m between the inner and outer rows of the wall. These micro-piles have a varying length (8, 10 and 12 m) depending on the strain exercised by the upper structures. A 5 mm bituminous membrane will be laid on the outer side of the underpinning so as to protect the structure against the possible atmospheric precipitations. Outside, the excavation will be refilled with a

draining layer and the water will be collected in a PVC draining pipe with diameter of 200 mm that will be longitudinally placed along the outer wall perimeter (Fig. 5).

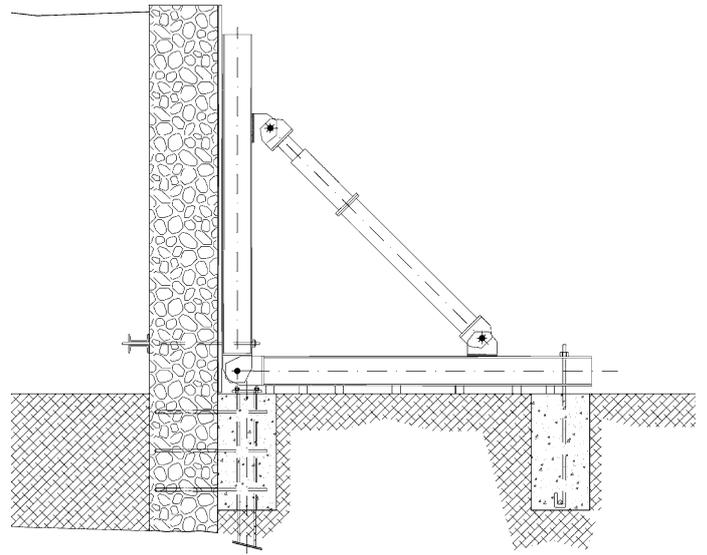
Figure 6. Straightening of the entrance wall. Hoisting of the containing wall with double-effect jacks.

4) Straightening of the entrance wall. The rotation of the supporting wall shows that the strain of the soil behind it is too high with respect to its dimensions and characteristics. In order to regain the safety conditions and to preserve the wall features, it is necessary to reinforce the wall by straightening it after removing the soil behind the wall itself (Fig. 6). The stages foreseen for the straightening intervention are described hereunder:

- Stage 1: Excavation behind the wall to place the anchors. Setting and installation of the hoisting device after preparing the concrete basements with dimensions 60×120 cm to enlarge the foundation basement; positioning of the steel bars or the connecting plates and of the hydraulic jacks needed to straighten the wall;

- Stage 2: hoisting of the containing wall with double-effect jacks (max capacity foreseen 70 tons) through cyclic feed and distribution. The hoisting will be performed through various phases. In this stage the two rows of anchors will also be placed.

- Stage 3: this stage entails the refilling behind the wall with draining material and the tensioning of the anchors. Disassembling of the hoisting metallic structure and the hydraulic jacks.

The characteristics of the hoisting equipment are described hereunder: a) jacks with total extension of 500 mm, with piston and carter made of highly-resistant steel, with double effect, maximum pressure of 600 bars and maximum capacity of 70 tons; b) oil-hydraulic power unit consisting of the distribution system of the pressure oil that comprises the solenoid valves, a rubber pipe to transport the high-pressure fluids with double-spiral braided reinforcement resistant up to 800 bars, with varying length and connected to the pressure readout data logger and to the joint placed inside the jacks; with interposed safety valve for the high pressures; c) 20 HP electric motor, 50 l tank and pump with pistons with proper capacity for the maximum number of connected jacks; d) pressure chambers with diameter 150 mm, stroke length 500 mm, and maximum capacity 70 tons, through cyclic feed and distribution.

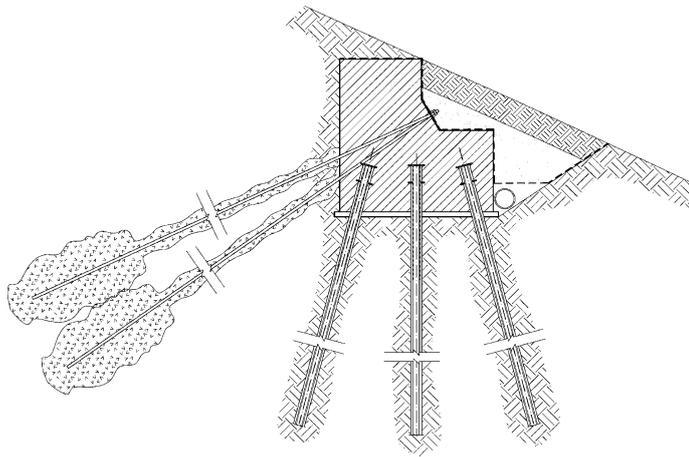
Figure 7. Reinforcement of the slope.

6) Reinforcement works of the slope (Fig. 7). The plan includes the construction of a system of micropiles (vertical and sub-vertical) that are connected at the top to a rigid reinforced concrete constraint structure where the permanent anchors find resistance. In the south-east side the reinforcement structure will be placed just next to the perimetric wall of the access road, while elsewhere it will be in the northern side at about 10 m from the castle walls.

Both vertical and sub-vertical micro-piles will have a hole diameter of 220 mm and a length varying from 9 to 15 m depending on their placement. The reinforcement consists of a steel pipe with diameter of 127 mm and thickness of 10 mm. Longitudinally the micro-piles will be placed every 1.20 m and the rows will be evenly staggered between the vertical and sub-vertical piles. The anchors will be active and permanent; in each hole with diameter of 180 mm there will be inserted 5 strands with diameter 0.6" and they will be repeatedly and selectively injected. Longitudinally, the anchors axes distance will be 2.40 m (Fig. 7). This kind of structure provides the following advantages: a) it is a draining structure, thus it does not hamper the natural flow of the seepage waters avoiding hazardous deposit and/or stagnations; b) this structure can improve both the local foundation stability (lateral confinement effect) and the global stability of the work; c) these micro-piles, that are properly connected to the reinforced concrete rigid connection structure, also work as a supporting structure against the possible stability problems due to its creeping towards the valley; d) the use of permanent anchors (pre-tensioned) will render the whole structure more reactive, which means that it will be able to give stability even with slight movements; e) the micro-piles technology well suits the soil characteristics: in fact, it permits drilling with limited vibrations that would otherwise damage the building and the perimetric walls. In the more compact areas it is possible to resort to rotary percussion drilling with a feed down-hole hammer.

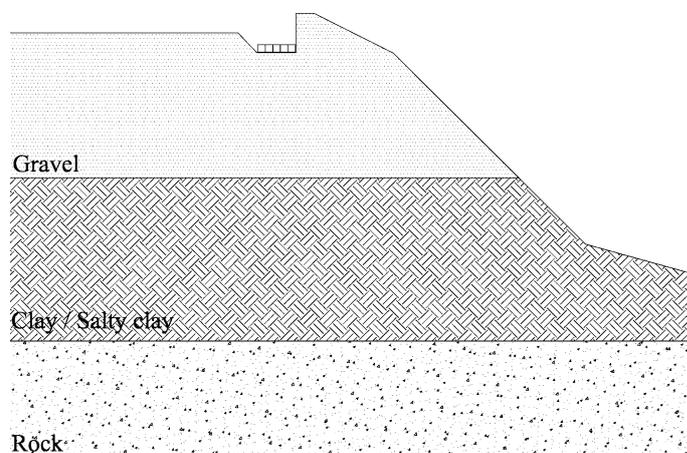
Figure 8. The geotechnical characterization adopted in the "FLAC" programme for numeric analysis. Layer 1: gravel and sand; Layer 2: clay and silt; Layer 3: rigid rock.

The "FLAC" programme has been used for the numeric analysis of the slope behaviour and to design the reinforcement intervention. The geotechnical characterization adopted is as follows (Fig. 8).

a) Layer 1: Gravels and sand. For the granulometry, see the description provided by the drillings. These show that it mainly consists of cemented sandy gravel. With respect to the weight of the unit of volume, the value is about 19 kN/m^3 . It must be considered that it is a medium- to thickened material. Three dynamic standard penetration tests SPT have been performed on this layer, two of them until refusal ($N_{spt} = 100$) and one provided a value $N_{spt} = 38$ at the depth of $4 \div 5 \text{ m}$.

b) Layer 2: Clay and silt. For the granulometry, see the description provided by the drillings (Jamiolkowski et al. 1979). These show that it mainly consists of clay and silt. With respect to the weight for unit of volume, the value is about 19 kN/m^3 . It must be considered that it is a material with medium consistency. The Pocket-Penetrometer tests performed in the drillings have showed values comprised between 100 and 700 kPa. These values can be correlated to an undrained shear resistance $c_u = 50 \div 350$ kPa. For the resistance parameters in drained soils, we can use the following values: effective cohesion $c' = 5 \div 15$ kPa and angle of shear resistance $\varphi' = 25 \div 28^\circ$.

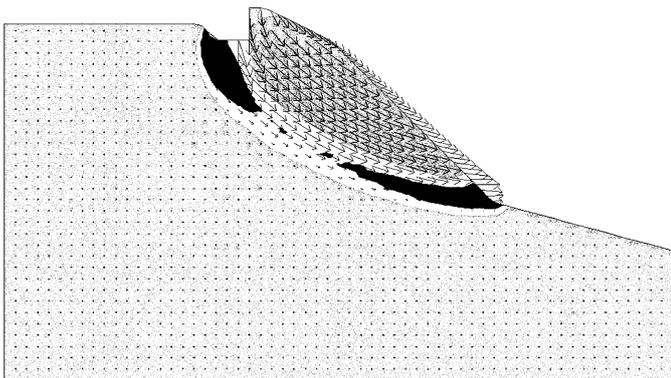
Figure 9. Calibration of underground model with back analysis of the resistance parameters (angle of shear resistance φ' considered constant). Output of "Flac" programme.

In this particular case, where the soils have both friction and cohesion (clay and silt, cemented sands and gravels), it was necessary to perform a back analysis (Fig. 9) of the resistance parameters and to consider reliable the values of the angles of shear resistance φ' . The cohesion c' is very difficult to assess and can be affected by the deposit structure. This parameter is defined through a sensitivity analysis to identify the value that gives the best interpretation of the average soil behaviour with respect to the problem under examination. In the calculation report, the castle perimetric wall has been considered by applying a load of 400 kN/m over a length of 2.0 m (pressure $q = 200$ kPa).

To sum up, the following shear resistance parameters have been calculated:

Layer 1 - Cemented gravels and sands. Effective cohesion $c' = 10$ kPa; angle of shear resistance $\varphi' = 40^\circ$.

Layer 2 - Clay and silt. Effective cohesion $c' = 10$ kPa; angle of shear resistance $\varphi' = 25^\circ$.

This provides a safety factor of the global stability equal to $FS = 1.12$ (pre-intervention safety factor), thus lower than the one set by the regulations in force.

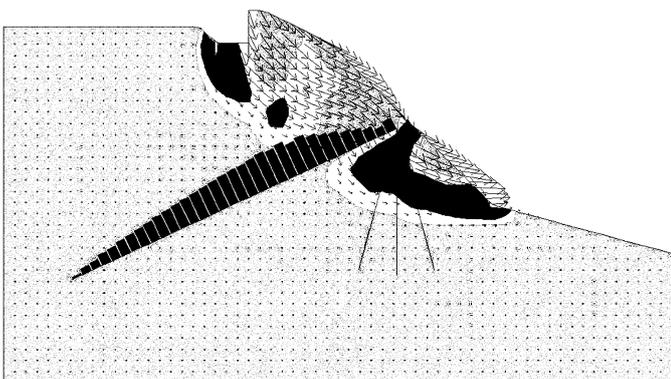
Figure 10. Analysis results: post-intervention stage. Output of "Flac" programme.

Figure 10 summarized the analysis results. The stability is ensured mainly through the restraint exercised by the anchors (post-intervention stage). The anchors have been designed as cables that interact with the surrounding soil through resistant connection elements. Thus the cable is effectively anchored outside the stabilizing structure and gives stability by transferring the lateral skin friction over the length that falls into the potentially unstable soil. This hypothesis has been provided by the programme employed and is a good outline of the real mechanism. Differently from the calculation hypothesis, the first stretch of the anchor within the potential unstable structure is free (passive earth pressure zone) and the stabilizing effect is exercised by the reinforced concrete constraint structure. The anchor was defined with the following characteristics: maximum axial resistance $N_{lim} = 1200$ kN/m; b) longitudinal axes distance between the anchors $d = 2.40$ m; c) interface unit strength resistance referring to the nominal hole diameter $D_p = 180$ mm equal to $\alpha\tau_{lim} = 200$ kPa. Cautiously, we did not take into account the flexional resistance contribution of the micro-piles.

The Figure 10 shows the results of the stability analysis after the intervention. The main results obtained are: post-intervention safety factor $FS = 1.35 (>1.30)$; maximum axial thrust on the anchors with balance limit of the slope $N_{max} = 412$ kN/m.
